# LOWER THAMES RIVER BASIN
# NORWICH, CONNECTICUT

# TRADING COVE POND DAM
# CT 00237

## PHASE 1 INSPECTION REPORT
## NATIONAL DAM INSPECTION PROGRAM

JUNE 1981

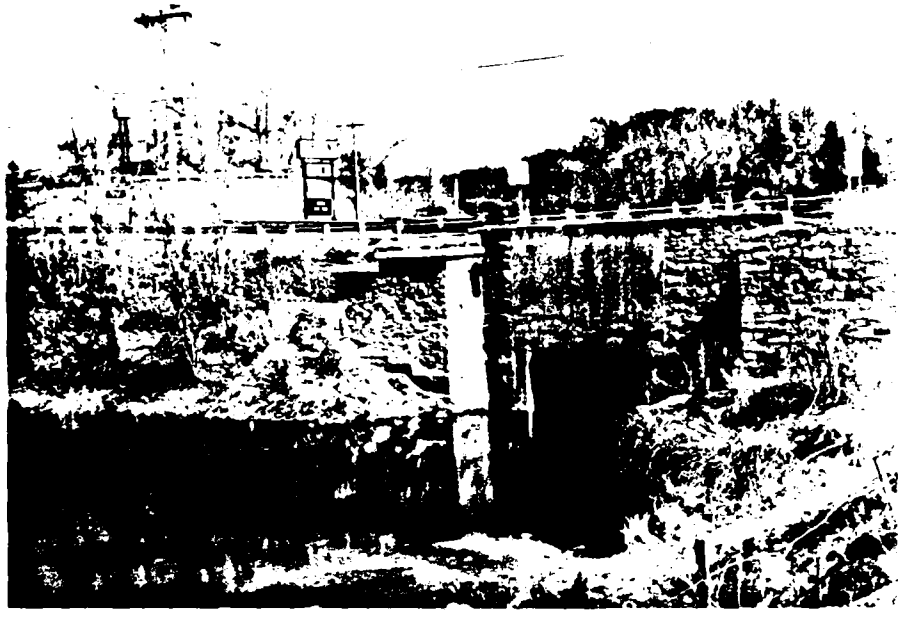
2. Upstream Slope: The upstream slope of the dam consists of an ashlar masonry wall near the crest and an earth embankment on the lower part of the slope (see Photo 1). Part of the wall on the left side of the spillway has been gunited. Some of the gunited areas near the spillway have begun to show signs of spalling, as seen in Photo 1. To the right of the spillway there are areas which have mortar missing from between the stone blocks. Earth fill has been placed against the lower part of this wall, but the fill has a very irregular surface and an extensive growth of small trees. The retaining wall just to the left of the spillway has also been gunited and has had PVC drain pipes installed about 2 to 3 feet into it.

1. Spillway: The spillway consists of an ashlar masonry structure with flashboards (Photo 2) and training walls on both sides (Photo 1). The spillway discharge channel passes through the dam. The upstream and downstream sections of the channel are a concrete box structure, while the central section has ashlar masonry walls and a concrete slab roof (Photo 6). There are drain holes in the downstream section of the channel and both the concrete and ashlar masonry appear in good condition. There was no flow observed coming out of the drain holes along the masonry or concrete walls. Minor efflorescence and evidence of seepage were observed on the masonry walls.

Photo 1. Upstream view of the dam from parking lot at edge of pond. Note cement bag retaining wall at left end of culvert embankment.

Photo 2. Spillway weir and flashboard at inlet of culvert.

3. Regrout the upstream ashlar masonry wall and repair the gunited section.

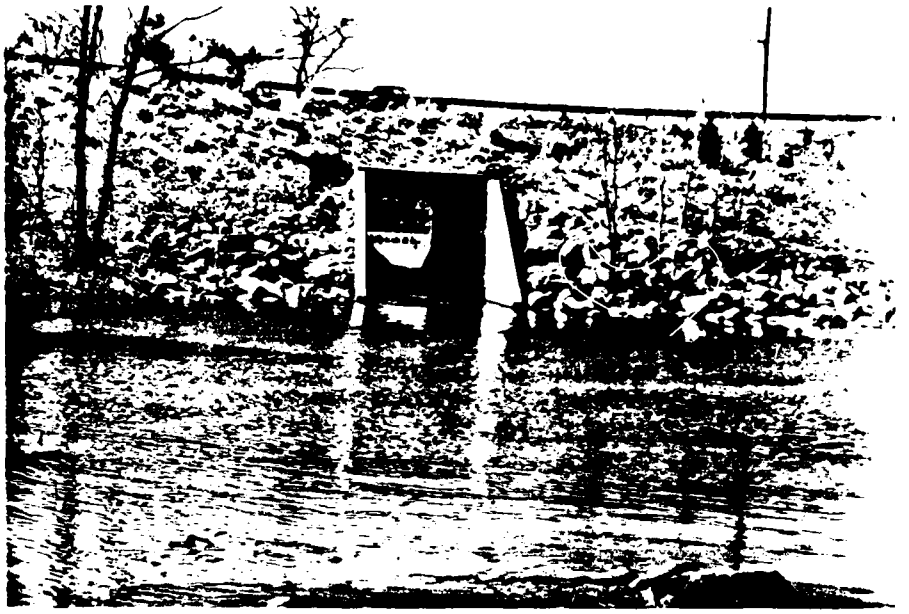
grass slope with some brush and small trees (up to a trunk diameter of 3 inches) growing on it (Photo 3). There are some footpaths along the slope which have resulted in erosion, particularly near the wing walls of the outlet channel to the spillway, as seen in Photos 3 and 4. The erosion here is as deep as 2 feet along the right side of the structure. No seepage or sloughing of the embankment was observed along any of the downstream areas. The lower part of the slope is protected against tail water erosion by riprap which extends about 10 feet up the slope in the vicinity of the wing walls of the outlet structure.

Photo 3. View of downstream slope of dam and spillway weir on upstream side (as viewed through the culvert). Note erosion along both wing walls of culvert outlet.

1. Repair the erosion adjacent to the wingwalls of the culvert on the downstream slope of the dam with crushed stone.

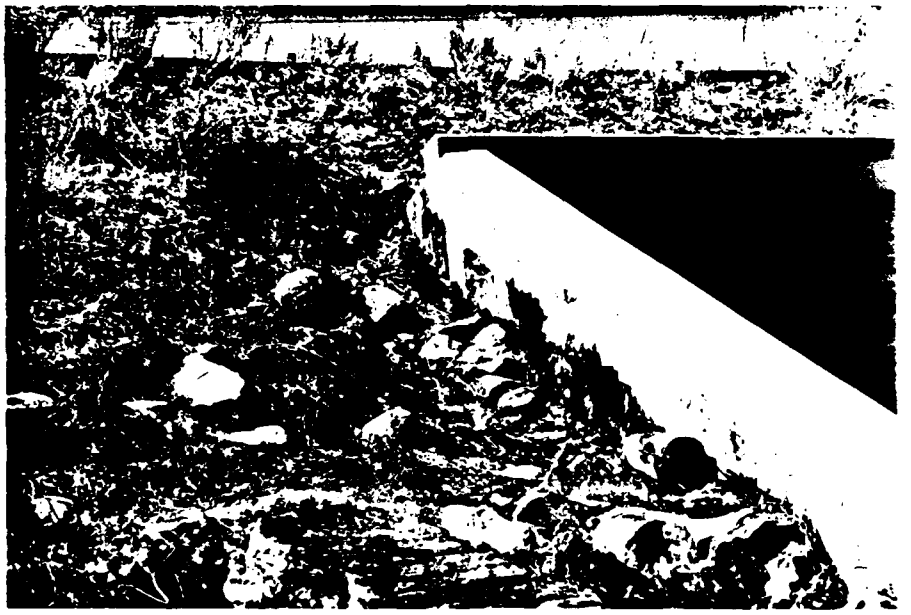
| AREA EVALUATED | CONDITION |
|---|---|
| Condition at Abutment and at Concrete Structures | *Erosion gullies on downstream slope along spillway walls.* |

Photo 4. Closeup of erosion along the right wing wall of the culvert outlet.

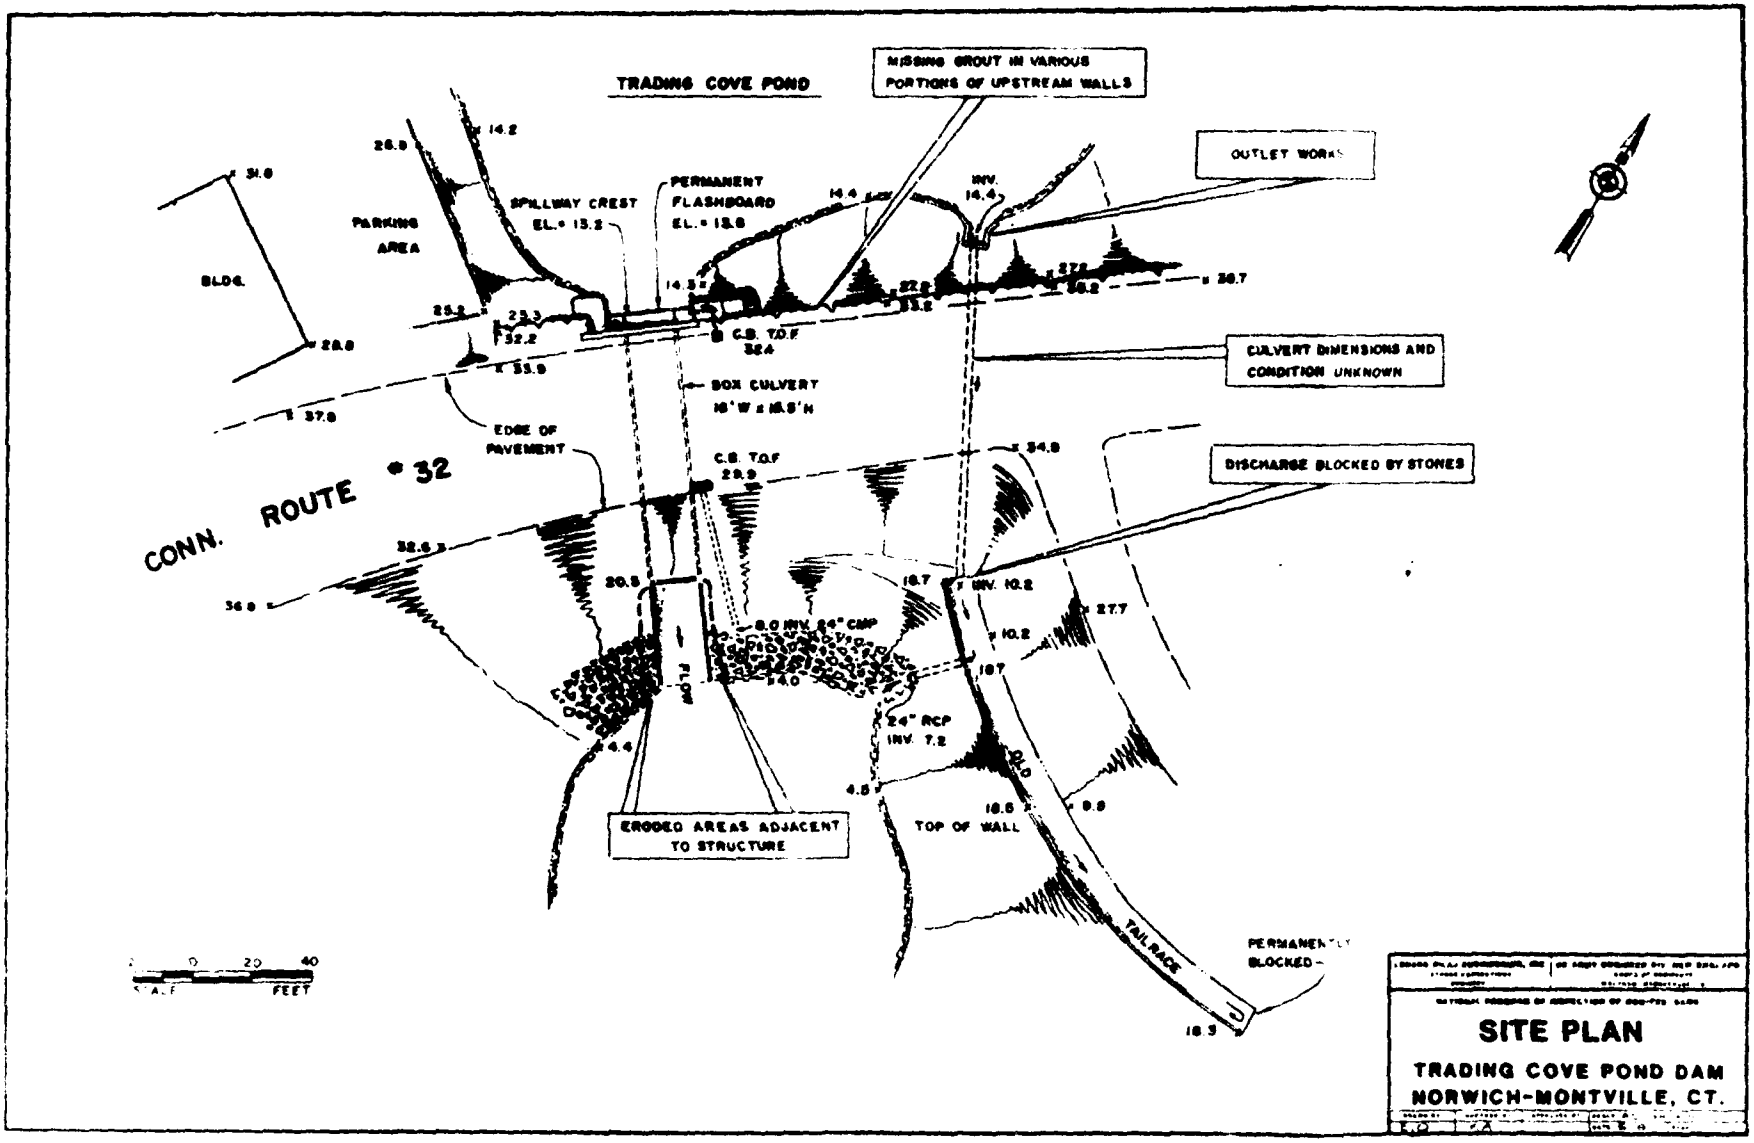
TRADING COVE POND
MISSING GROUT IN VARIOUS PORTIONS OF UPSTREAM WALLS
OUTLET WORKS
PERMANENT FLASHBOARD EL. = 13.8
SPILLWAY CREST EL. = 13.2
PARKING AREA
BLDG.
INV. 14.4
CULVERT DIMENSIONS AND CONDITION UNKNOWN
BOX CULVERT
C.B. T.O.F 32.4
EDGE OF PAVEMENT
CONN. ROUTE 32
C.B. T.O.F 29.9
DISCHARGE BLOCKED BY STONES
INV. 10.2
8.0 INV. 24" CMP
24" RCP INV. 7.2
FLOW
ERODED AREAS ADJACENT TO STRUCTURE
TOP OF WALL
TAILRACE
PERMANENTLY BLOCKED
SCALE 0 20 40 FEET
SITE PLAN
TRADING COVE POND DAM
NORWICH-MONTVILLE, CT.

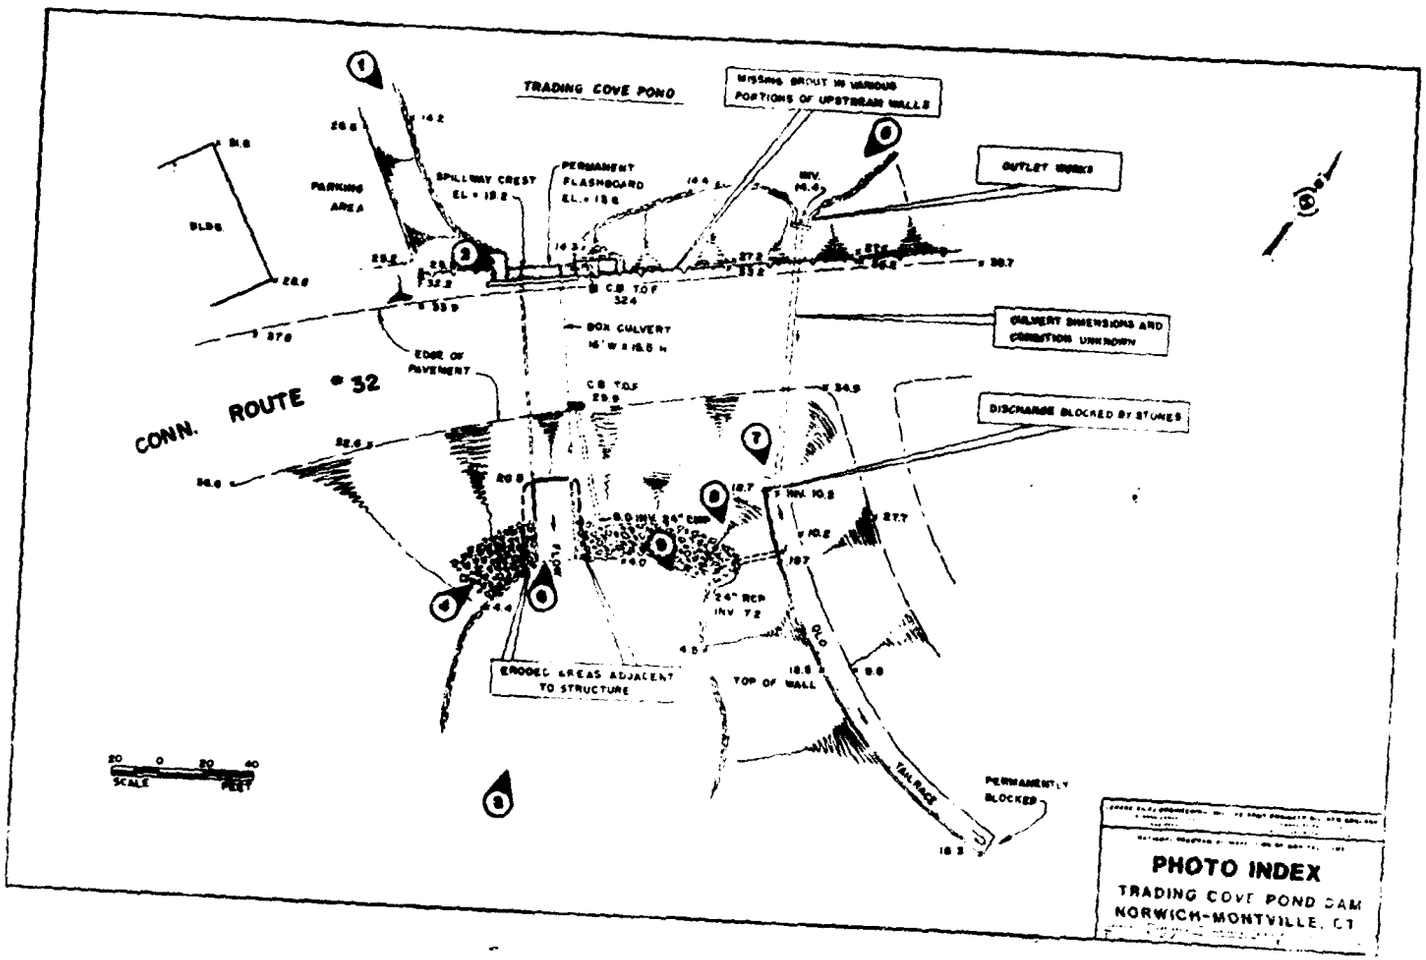
TRADING COVE POND
MISSING GROUT IN VARIOUS PORTIONS OF UPSTREAM WALLS
OUTLET WORKS
SPILLWAY CREST EL. = 19.2
PERMANENT FLASHBOARD EL. = 19.6
PARKING AREA
BLDG.
CONN. ROUTE # 32
EDGE OF PAVEMENT
C.B. TOP 32.4
BOX CULVERT 16' W x 16.5' H
CULVERT DIMENSIONS AND CONDITION UNKNOWN
C.B. TOP 29.9
DISCHARGE BLOCKED BY STONES
FLOW
24" RCP INV. 7.2
ERODED AREAS ADJACENT TO STRUCTURE
TOP OF WALL
TAILRACE
PERMANENTLY BLOCKED
SCALE FEET
PHOTO INDEX
TRADING COVE POND DAM
NORWICH-MONTVILLE, CT
